**Central Pollution Control Board
Zonal Office (South)
Nisarga Bhavan, Thimmaiah Road,
Shiva Nagar, Bangalore – 560010.**

Inspection report of M/s Ramky Energy & Environment Ltd, Common Bio-Medical Waste Treatment Facility (CBMWTF), Mangalore, Karnataka during August, 2013

The Common Bio-Medical Waste Treatment Facility (CBWTF) of M/s Ramky Energy & Environment Ltd., located at Mulki, Mangalore, Dakshina Kannada District was visited by a team of officials from Zonal Office, Bangalore on 23.08.2013 and the compliance is as given below:

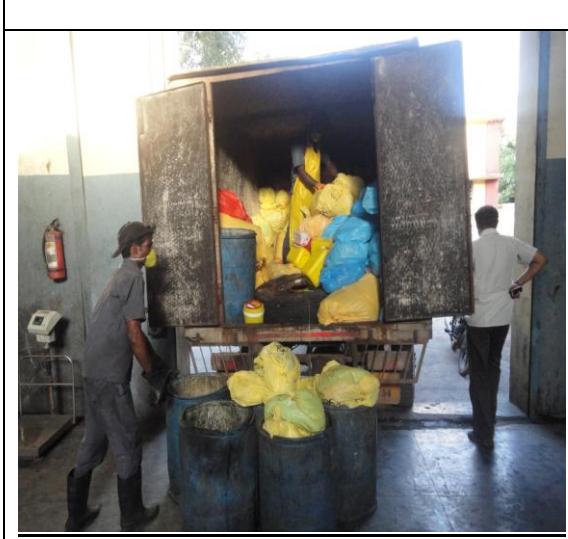
| Fig.5: Unloading of Bio-Medical Waste | Fig.6: Storage of Bio-Medical Waste |

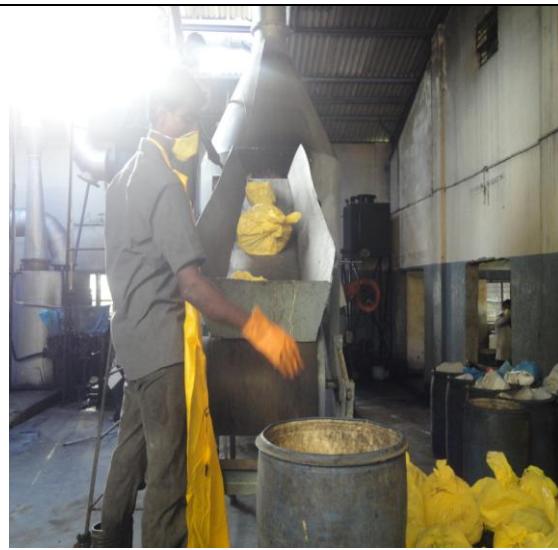
Fig.7: Loading of Bio-Medical Waste in Conveyer system

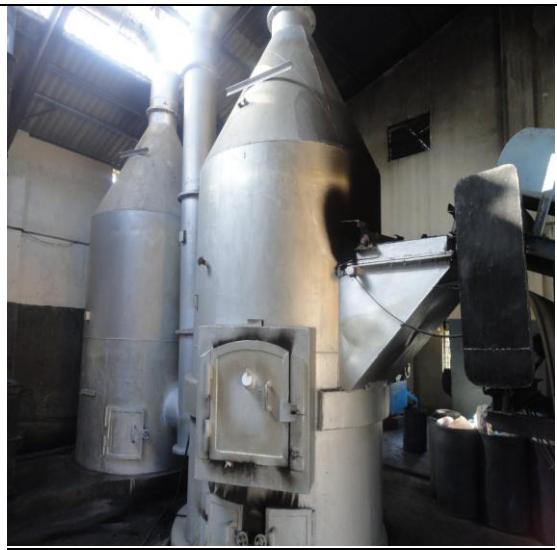
5. The Programmable Logic Control (PLC) based control system installed with the incinerator was found not working and it was noticed during the inspection that the operating parameters of the incinerator were controlled manually.

6. Fugitive emissions inside the facility were observed due to leakage of flue gas from the duct connected to stack.
7. The devices for measuring negative draft in primary chamber, air flow rate in the incinerator chamber and pressure drop across venture scrubber are not attached with the incinerator.

8. The flue gas analyser was not available to measure the parameters like O₂, CO & CO₂ in the exit stack gas.
9. The automatic recording of the operational parameters of the incinerator and tamper proof PLC based control system for feeding the waste to the incinerator are not installed.

Fig.8: Primary & secondary chambers

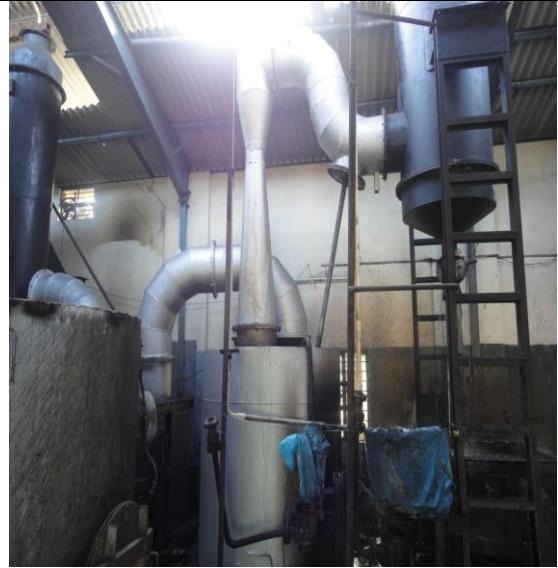
Fig.9: Quencher & Ventury Scrubber

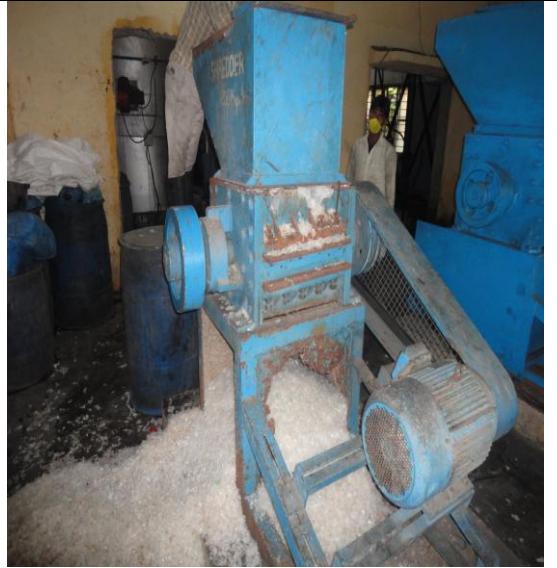
Fig.10: Shredder

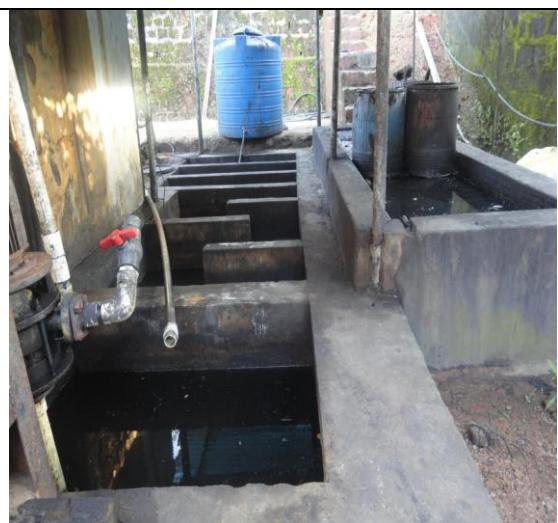
13. DG Set is not equipped with acoustic enclosure as required as per the norms
14. The unit is having a small ETP to treat the waste water. At the end of the day, the re circulated water stored in Quencher, Ventury and Scrubber tanks is taken to ETP where it is neutralized using alkali and then passed through sand filter. The sand filter outlet is collected in a tank called as final treated water tank. This treated water is reused for re circulation in the scrubbers the next day. The vehicle wash water is also treated in a similar fashion in the same ETP and reused for scrubbers. No waste water is discharged from ETP after treatment. The measuring devices such as flow meter & pH meter are not installed at the outlet of ETP. The domestic waste water is treated in septic tank & soak pit.

Fig.11: ETP

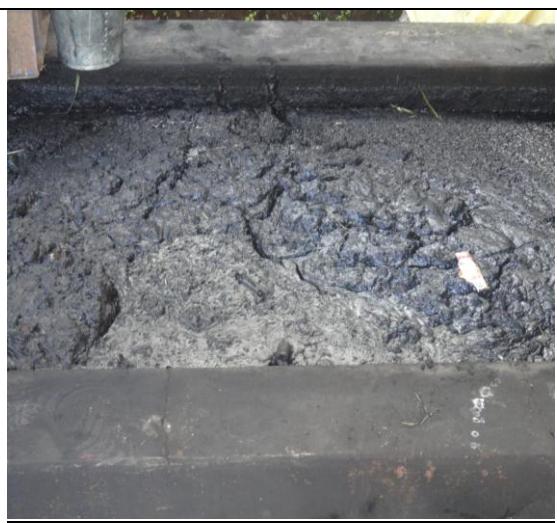
15. Sludge is removed once in 15 days from ETP (Neutralization Tank), Quencher, Ventury and Scrubber tanks and then allowed to dry in sludge drying beds. The dried sludge along with incinerator ash, sharps (after auto clay & shredding) are sent to TSDF, Dabaspet, Nelamangala Taluk, Bangalore Dist.

Fig.12: Sludge Drying Bed
